Xerox® VersaLink® C400 Color Printer & C405 Color Multifunction Printer Service Manual

Xerox® VersaLink® C400 Color Printer and C405 Color Multifunction Printer

VersaLink C400 Color Printer and C405 Color Multifunction Printer Service Manual

This manual is the primary document used for diagnosing, repairing, maintaining, and troubleshooting the Xerox® VersaLink® C400 Color Printer and Xerox® VersaLink® C405 Color Multifunction Printer. The Service Manual is the controlling publication for a service call. To ensure product understanding, complete the Xerox Service Training Program for these devices.

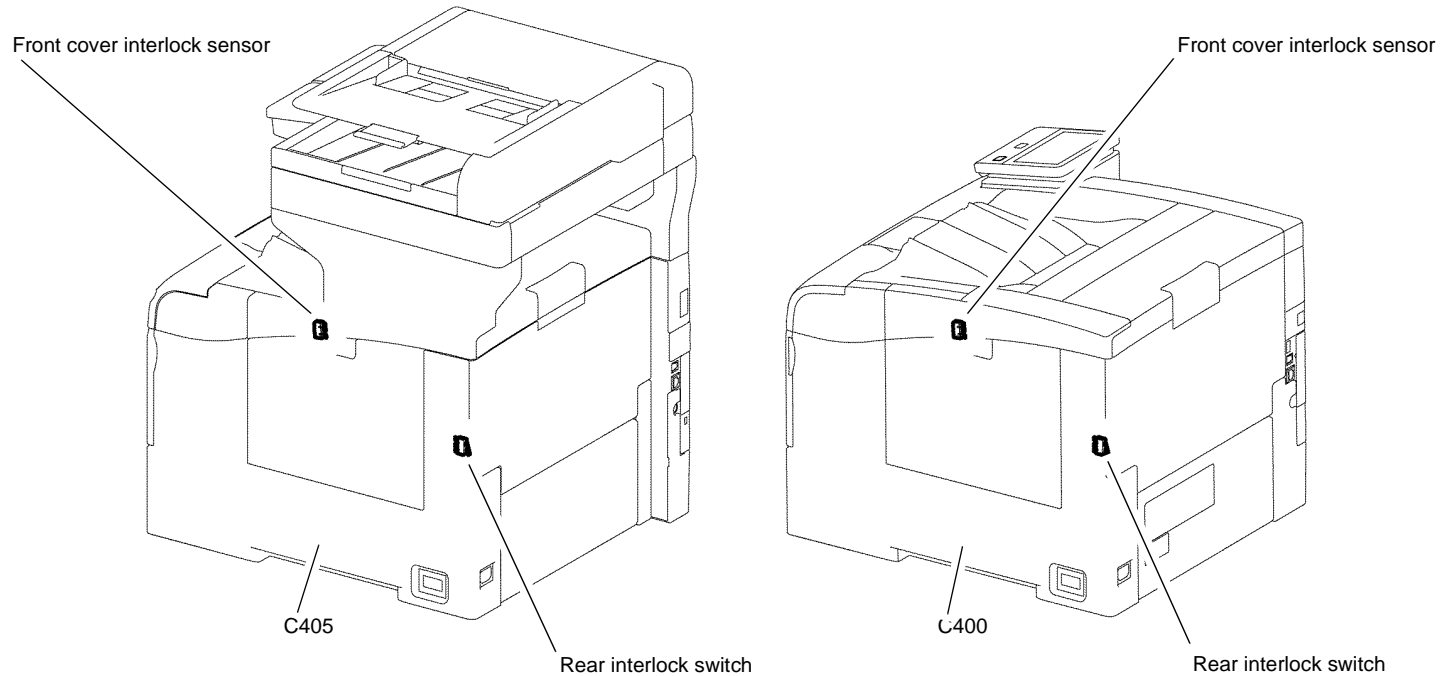
Z-1-0186-A

The C400 and C405 are provided with the following interlock safety devices, [Figure 1](#).

- Front cover interlock sensor, [PL 18.2 Item 28](#).
- Rear interlock switch, [PL 14.1 Item 3](#).

Figure 1 Interlock switches

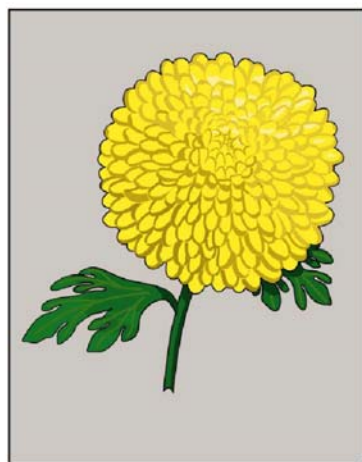
Z-1-0202-A

There is toner contamination on all or part of the page, [Figure 1](#). The contamination appears as a very light single or multi-color dusting or fog.

Figure 1 Background defect

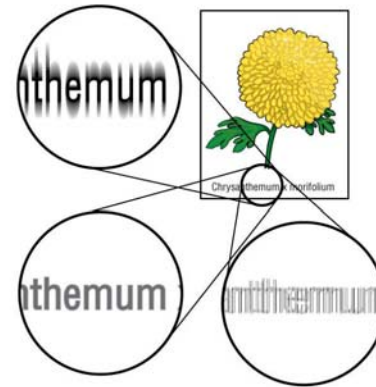
Z-1-0204-A

Text in image is fuzzy or blurry, Figure 1.

Figure 1 Jagged characters

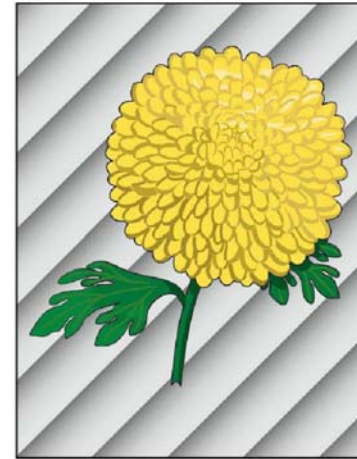
Z-1-0206-A

Auger marks appear across output, Figure 1.

Figure 1 Auger marks

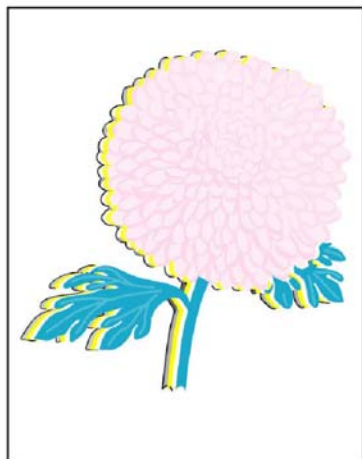
Z-1-0210-A

Image colors are not aligned with each other, [Figure 1](#).

Figure 1 Color reg misalignment

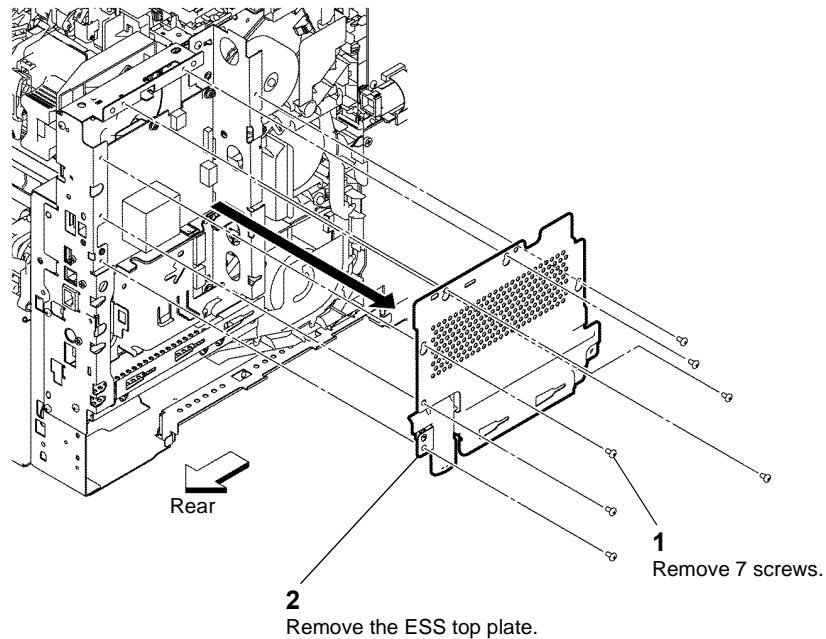
Z-1-0131-A

1. Remove the UI bottom left cover C400, [REP 1.5](#).
2. Remove the left side cover assembly C400, [REP 19.14](#).
3. Remove the ESS top plate, [Figure 1](#).

Figure 1 ESS top plate

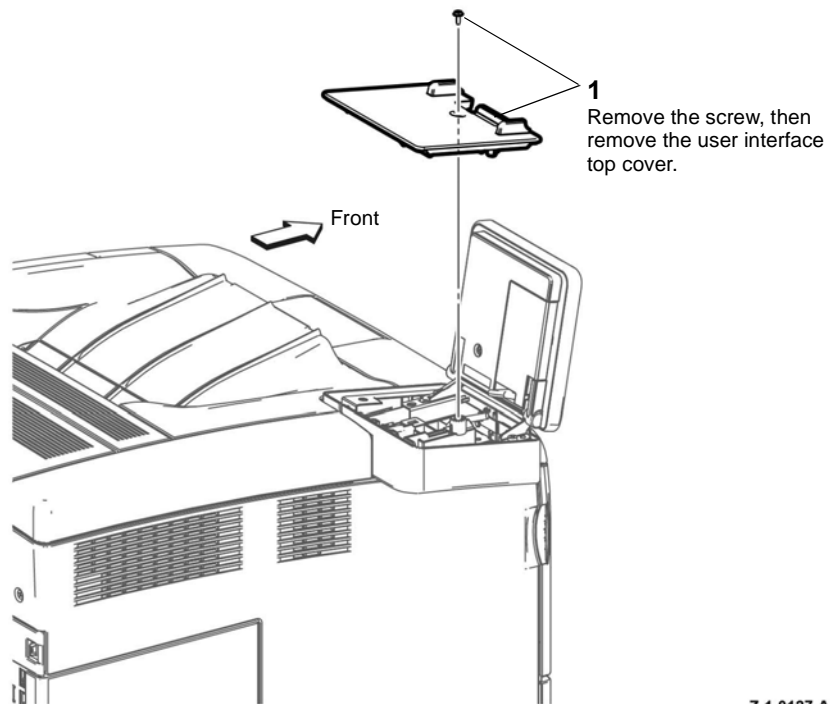
1. Remove the user interface top cover, [Figure 1](#).

Figure 1 User interface top cover C400

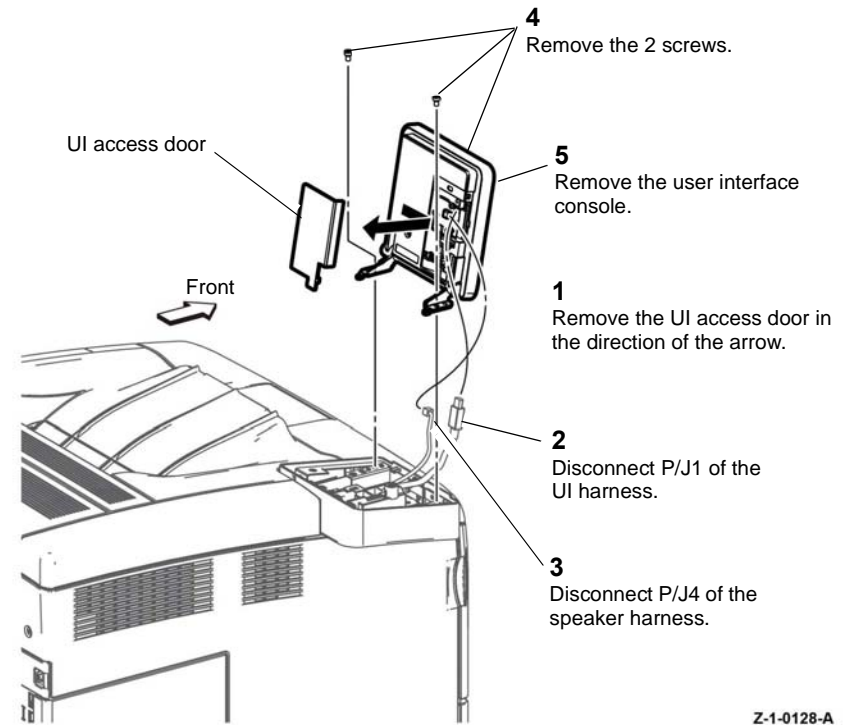
2. Remove the user interface console, [Figure 2](#)

Figure 2 User interface console C400

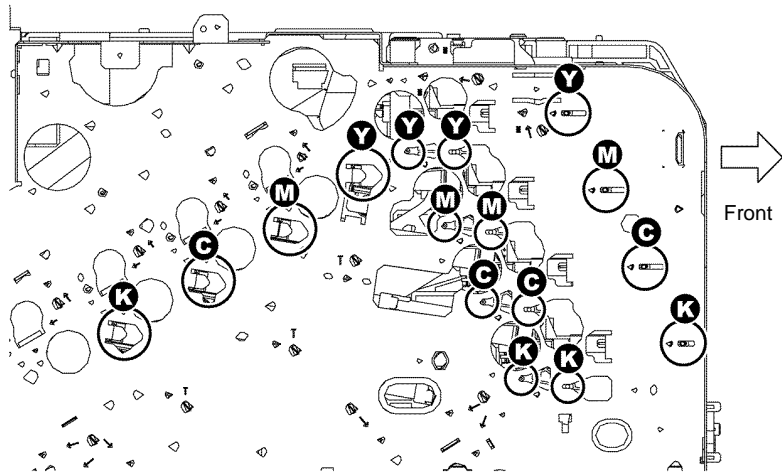
Z-1-0043-A

NOTE: The rear hook placement can not be seen when the main drive assembly is installed. Visually check that the rear hook is in the correct position by looking into the area behind the hook where the imaging units are installed.

3. Before securing the dispenser assemblies, ensure that the front lug and the rear hook for each dispenser assembly is in the correct position, [Figure 3](#).

Figure 3 Dispenser assemblies installation

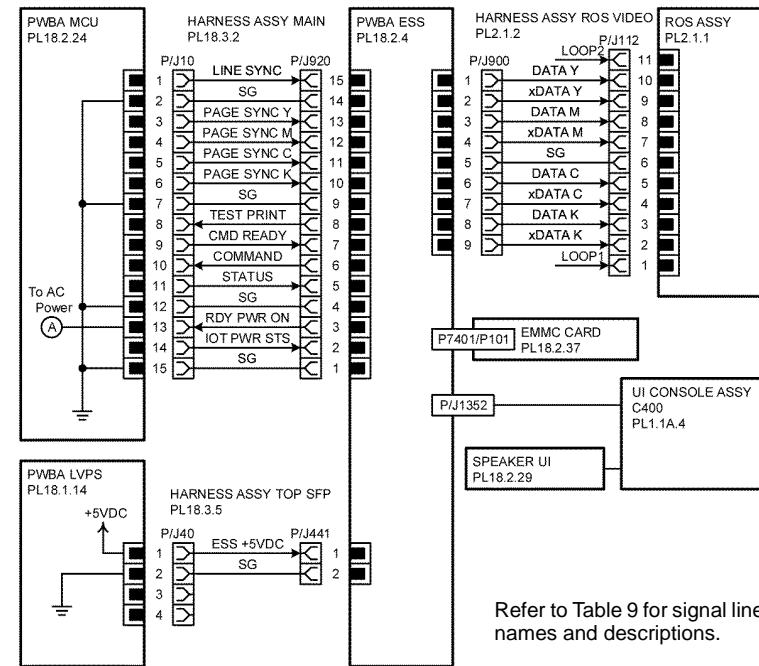
WD 10 Controller C400

Refer to Table 9 for signal line names and descriptions.

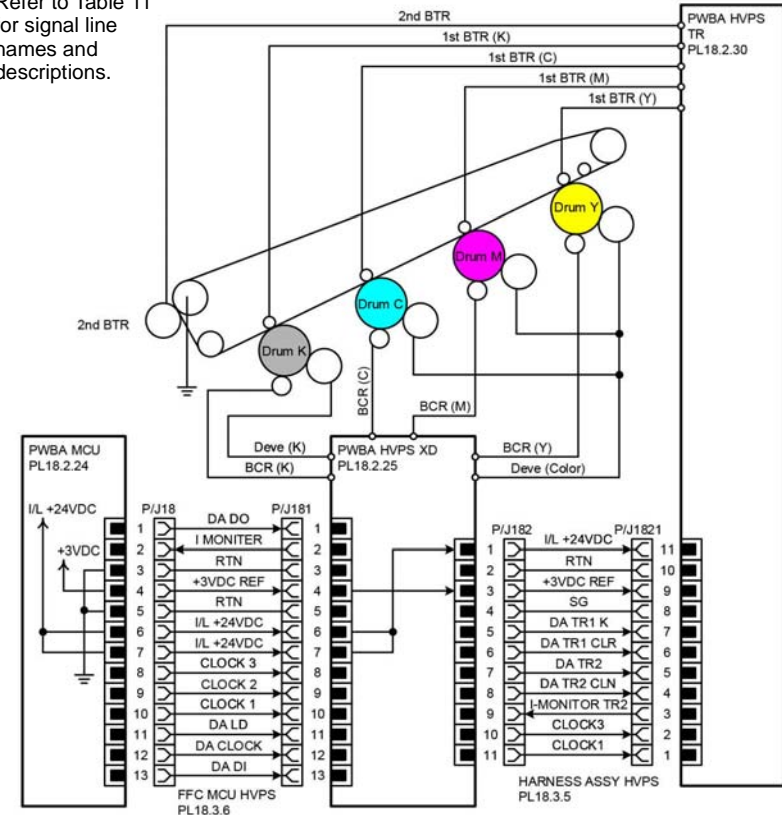
WD 12 HVPS

Refer to Table 11 for signal line names and descriptions.

Signal line name	Description
DA DOI MONITOR+3VREFI/L +24VDC CLOCK 3 CLOCK 2 CLOCK 1 DA LD DA CLOK DA DI	Control signal of the HVPS
TR1 K DA TR1 CLR DA TR2 DA TR2 CLN I-MONITOR TR2 CLOCK3 CLOCK1

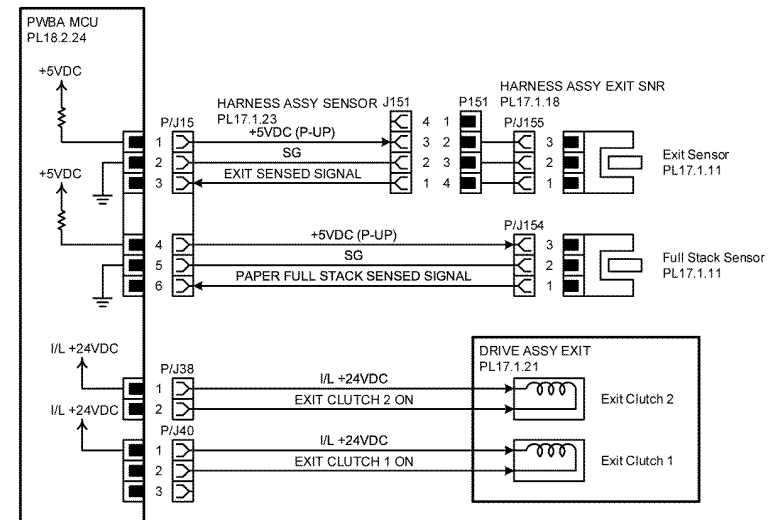
WD 15 Exit

Refer to Table 14 for signal line names and descriptions.

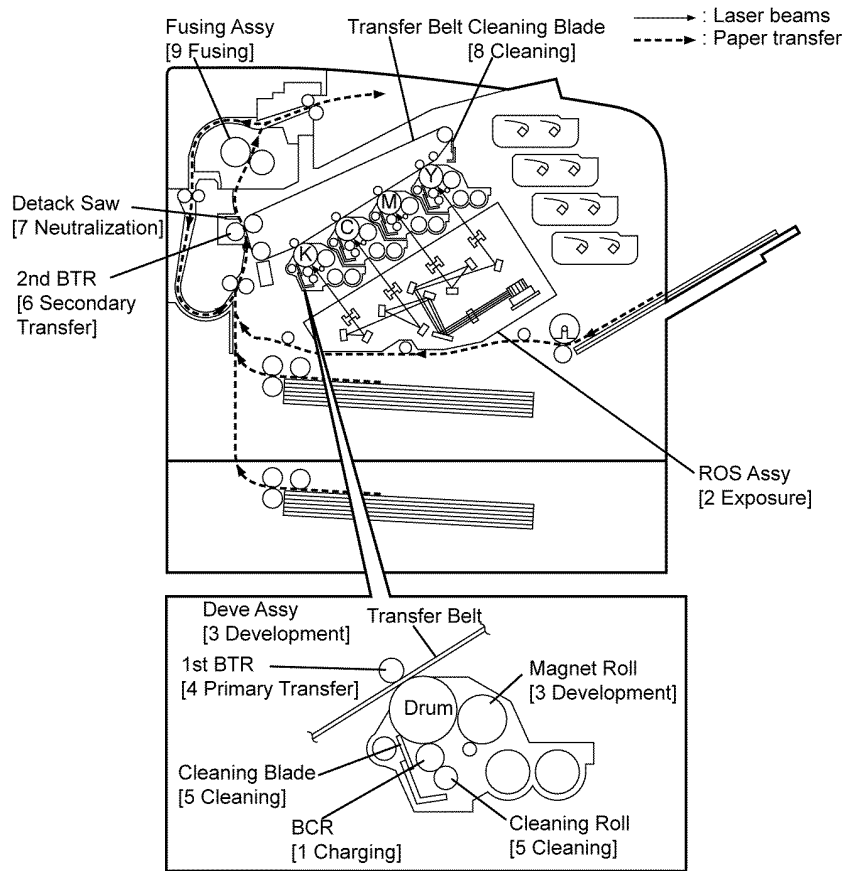
Figure 2, illustrates the printing process.

Figure 2 Printing process

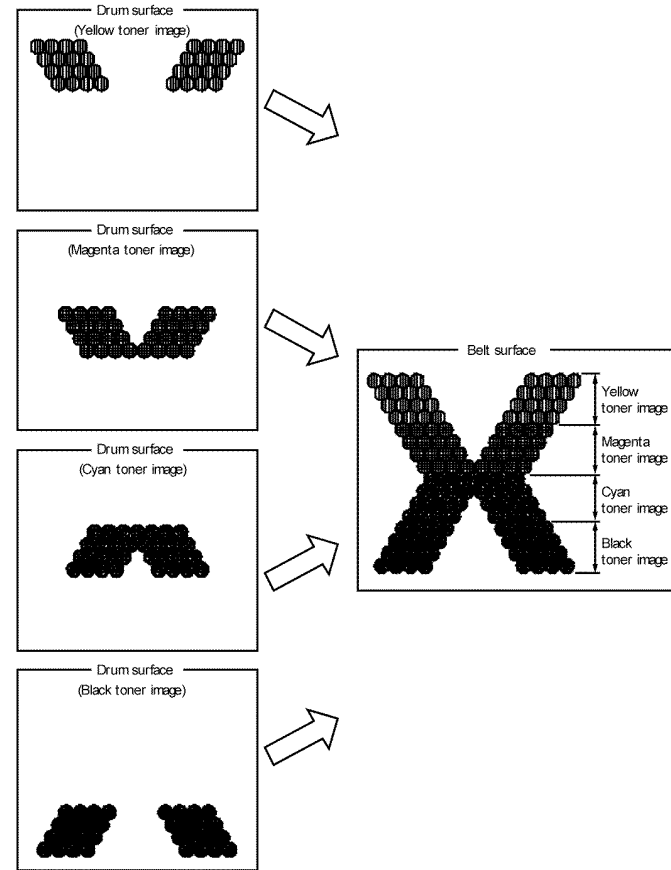
The 1st BTR is a metal roll, to which the positive voltage from the High Voltage Power Supply (HVPS) is applied. The 1st BTR positively charges the backside of the IBT with the voltage generated by the contact resistance with the IBT. The toner images on the drums are transferred to the IBT due to the attracting force generated between the negative polarity of the toner image and the positive polarity on the IBT, [Figure 9](#).

Figure 9 Drum to IBT transfer

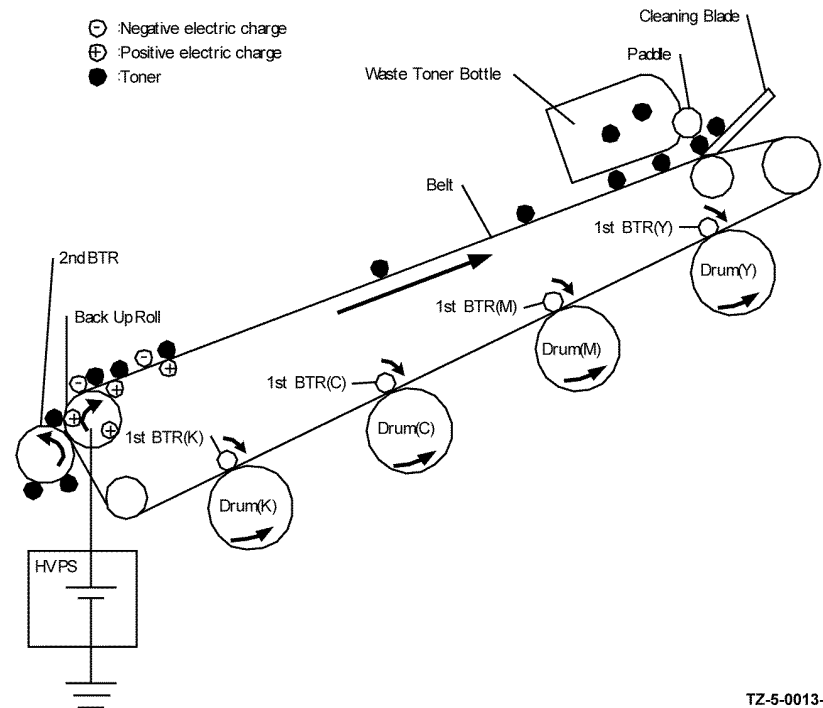
The excess toner that was not transferred to the print medium in the secondary transfer process remains on the IBT surface. To prevent the excess toner from causing trouble in the subsequent processes, the toner is scraped off by a cleaning blade in contact with the IBT surface, and then is collected into the waste box assembly, refer to Figure 13.

The excess toner deposited on the 2nd BTR in the secondary transfer process soils the back-sides of the subsequent sheets. To prevent this trouble, the excess toner on the 2nd BTR is transferred back onto the IBT using the attracting force generated by the back up roll. The back up roll is positioned opposite the 2nd BTR and is positively polarized by DC voltage from the HVPS. The excess toner remaining on the IBT is scraped off by the belt cleaning Blade that is in contact with the IBT, and is then collected into the waste box assembly, Figure 13. Refer to NOHAD & Waste Toner.

Figure 13 IBT and 2nd BTR cleaning

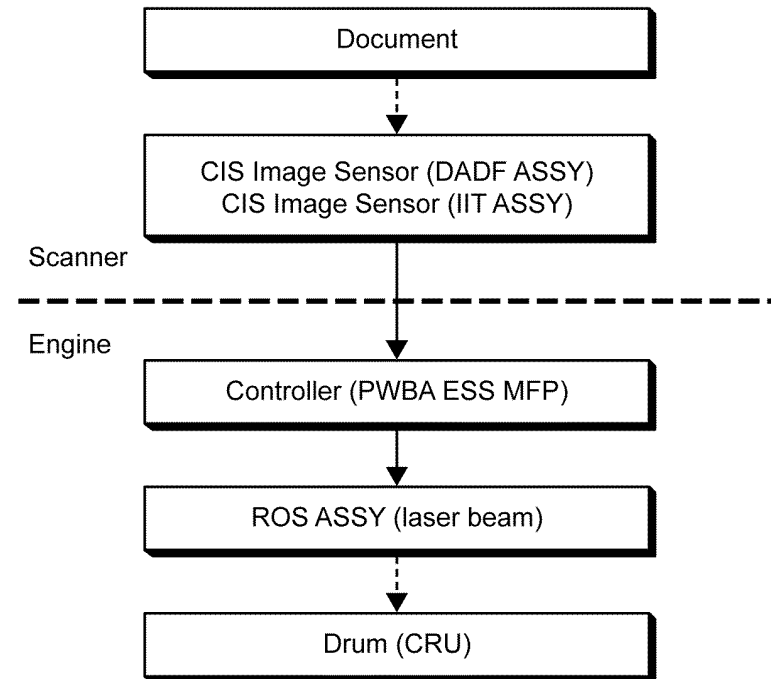
Figure 2 Image data flow

The image data from the document on the IIT or DADF encounters the components that follow before it is processed in the print engine section, [Figure 2](#).
